# DAM SAFETY INSPECTION REPORT

Woodside Lake Dam

File Number: 1005-008

Inspection Date: April 19, 2016

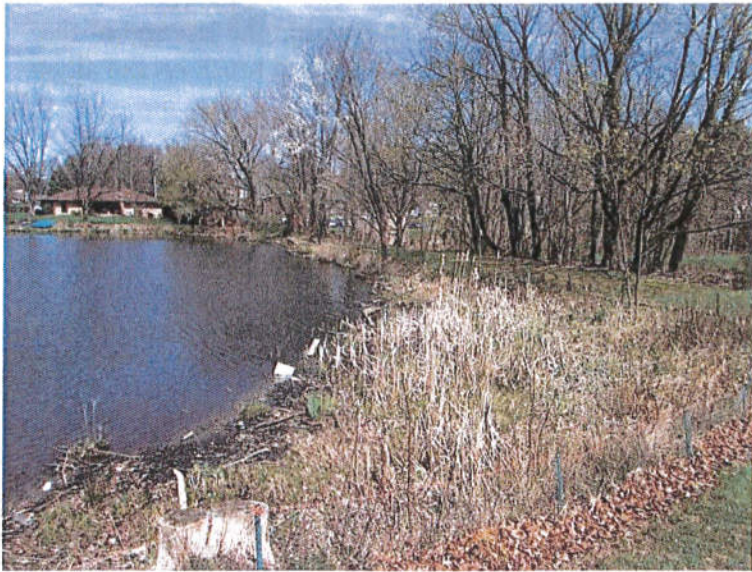
Photograph No. 1: View of the upstream slope from the right abutment. Note the tall vegetation growing on the slope.

None	Monitor	Repair	Engineer
- Trees and brush along slope			<input checked="" type="checkbox"/>	
- Tall vegetation along slope			<input checked="" type="checkbox"/>	
- Rodent burrows along shoreline			<input checked="" type="checkbox"/>

- No owner repairs for this report.
- Trees and brush are not permitted on embankment surfaces or earthen spillways.  
*Clear the trees, brush, and tall vegetation from the entire embankment and establish a healthy grass cover on the dam.*
- The embankment crest must have a uniform elevation.  
*Level the crest.*
- Rodent burrows weaken dam embankments and must be repaired. Rodent activity must be controlled.  
*Eliminate the rodent population and repair the rodent burrows on the dam.*
- The embankment and spillways must be protected from erosion. A healthy grass cover should be present on embankment and spillways as needed, and rock riprap must be cleared of vegetation and replenished periodically.

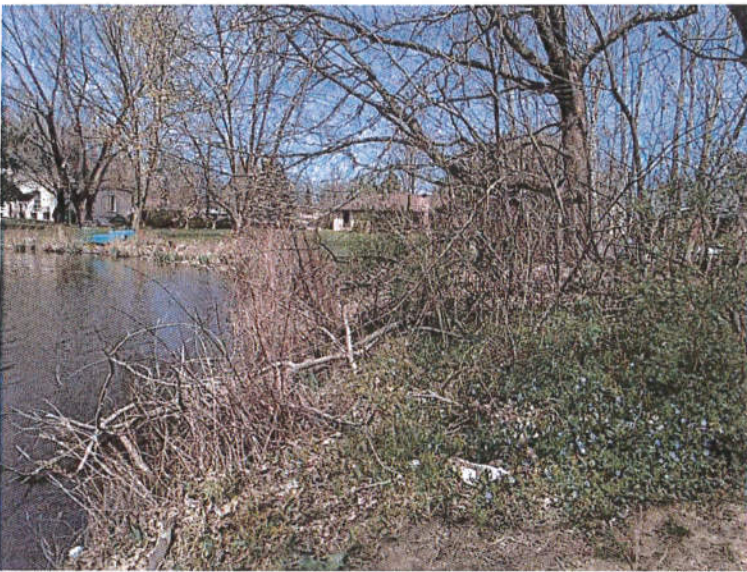
Photograph No. 2: Another view of the upstream slope.

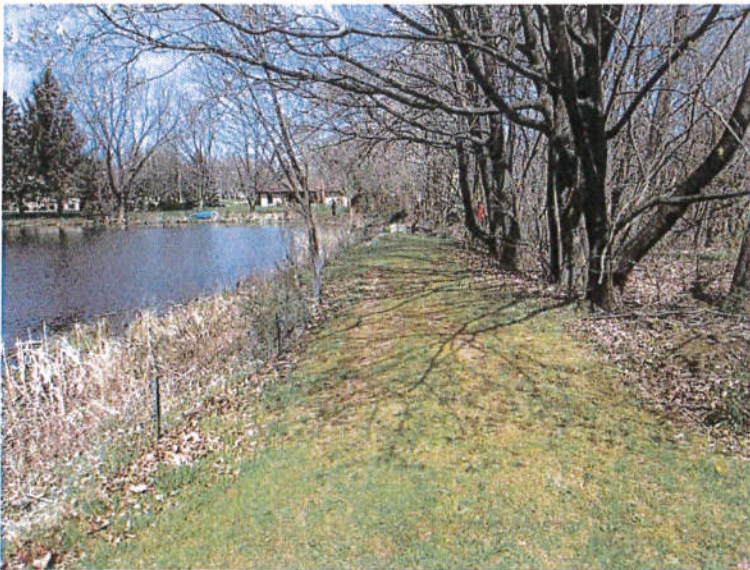
Photograph No. 3: View of the crest from the right abutment.

None	Mon.	Rep.	Eng.
- Trees and brush			<input checked="" type="checkbox"/>	
- Multiple low areas along crest			<input checked="" type="checkbox"/>	
- Sparse areas of grass on right half			<input checked="" type="checkbox"/>

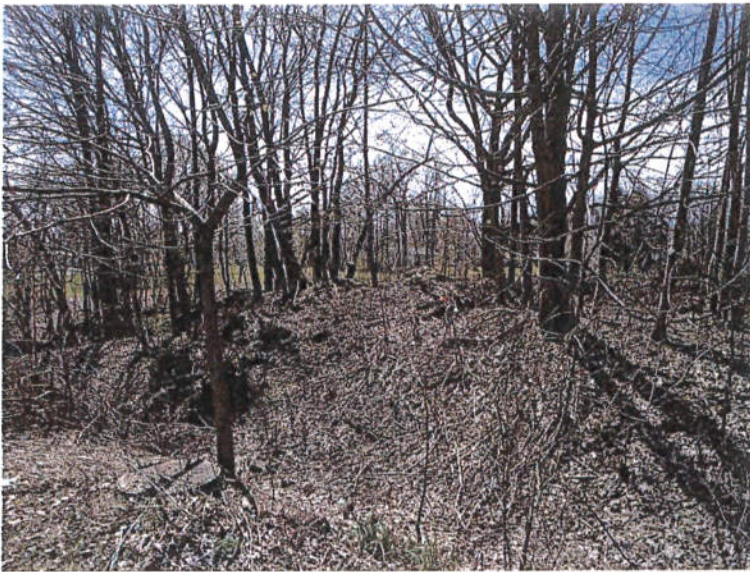
Photograph No. 4: View of the downstream slope from the left end of the dam. Note the trees and brush on the slope.

None	Mon.	Rep.	Eng.
- Trees and brush along entire slope			<input checked="" type="checkbox"/>	
- Debris dumped onto downstream slope			<input checked="" type="checkbox"/>	
- Severe erosion on slope were seepage through cutoff wall is occurring				<input checked="" type="checkbox"/>

- 
- Remove the debris that has been dumped on the downstream slope.*
- 
-

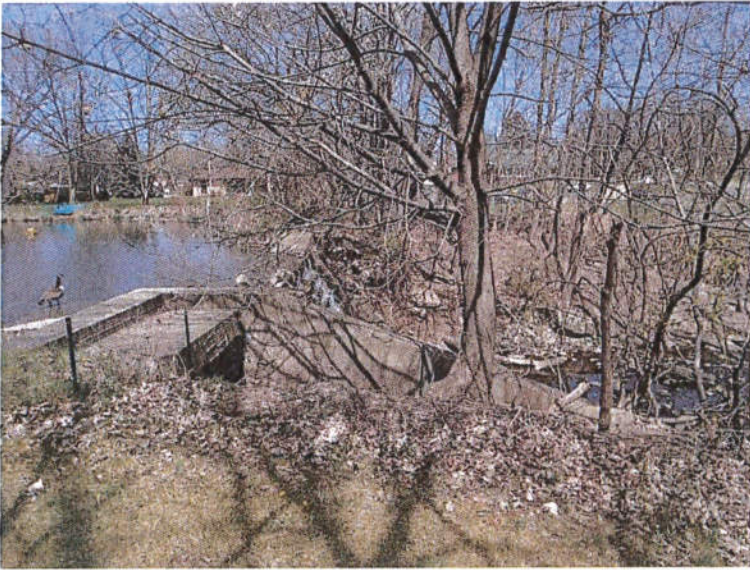
Photograph No. 5: View of the downstream slope from the left end of the dam.

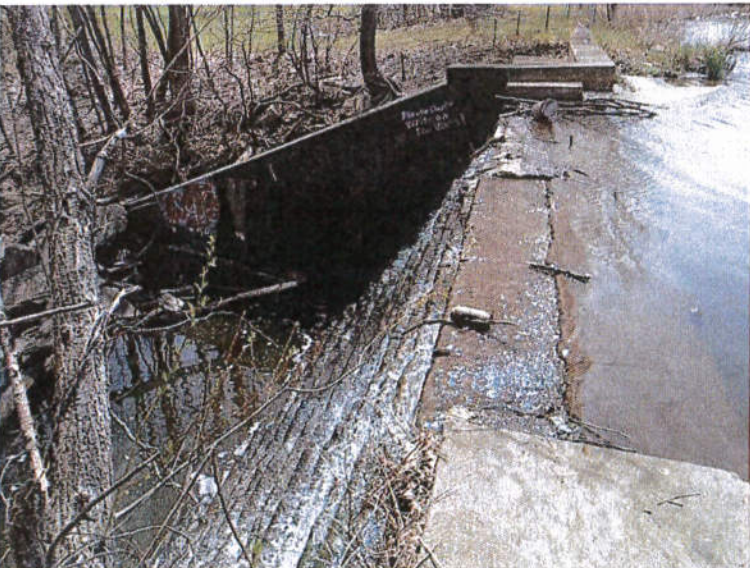
Photograph No. 6: View of the principal spillway weir.

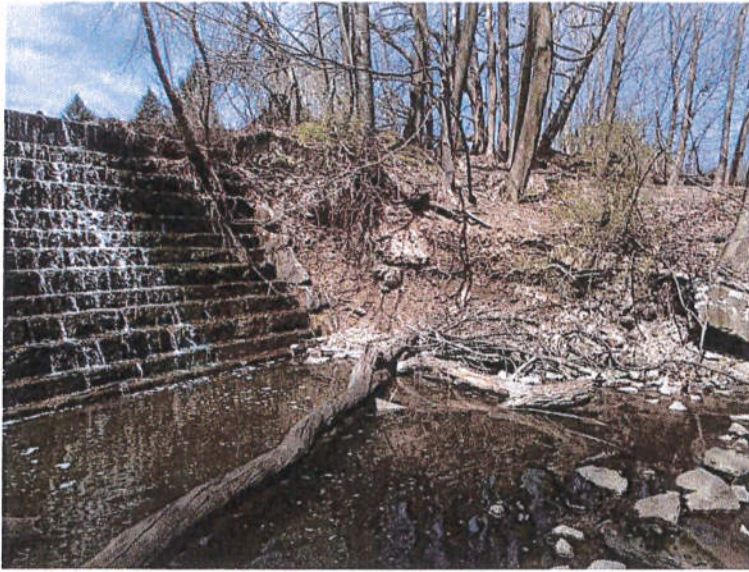
During the inspection, collapse of the left spillway sidewall and significant seepage through the right sidewall and embankment were noted. The dam and its spillway are in poor condition and steps must be taken to repair the dam within the next year before conditions worsen. You should consider lowering the pool level behind the dam by at least 2 feet until the dam is either properly repaired or breached. Please contact our office to discuss the next steps and options for lowering the pool level.

Photograph No. 7: View of the principal spillway. Note the right sidewall has collapsed and has been washed downstream.

2. The entire spillway system must be replaced. Prepare plans and specifications for replacement of the spillway system. The condition of the spillway system must be monitored monthly and during large storm events for further deterioration. This item should be completed in coordination with Item 1 above.

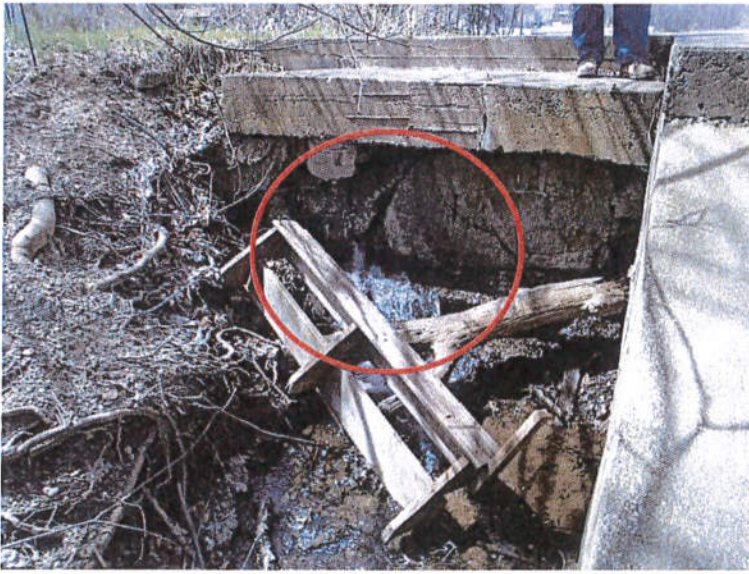
Photograph No. 8: View behind the left sidewall of the principal spillway. Note the large crack in the concrete and the large amounts of water seeping through.

3. The stability of the embankment must be maintained. Prepare plans and specifications for the repair of the concrete cutoff wall to the right of the right principal spillway sidewall, for the compacted fill that needs to be placed on the downstream slope where the seepage has eroded the slope, and for the installation of a seepage drain pipe behind the right principal spillway sidewall. The crack in the cutoff wall and overall stability of the embankment must be monitored monthly and during large storm events.

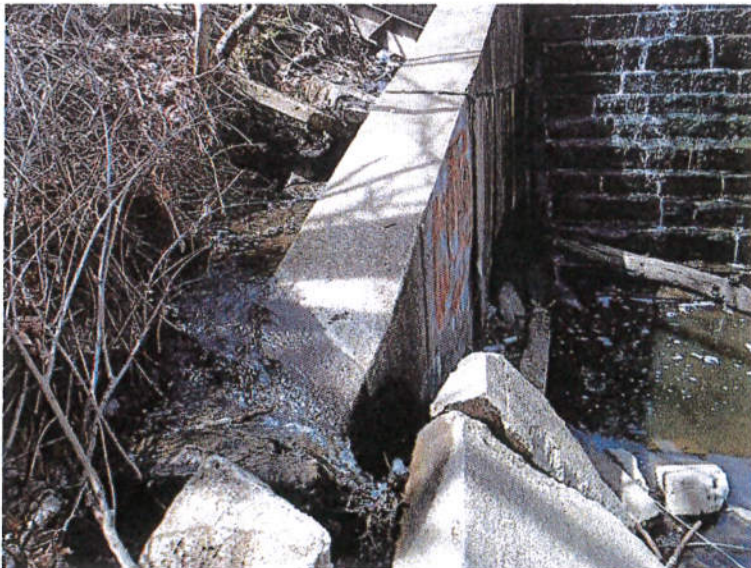
Photograph No. 9: View of the left sidewall. The water leaking from the crack in the picture above is eroding the soil behind the sidewall and seeping through cracks in the sidewall.

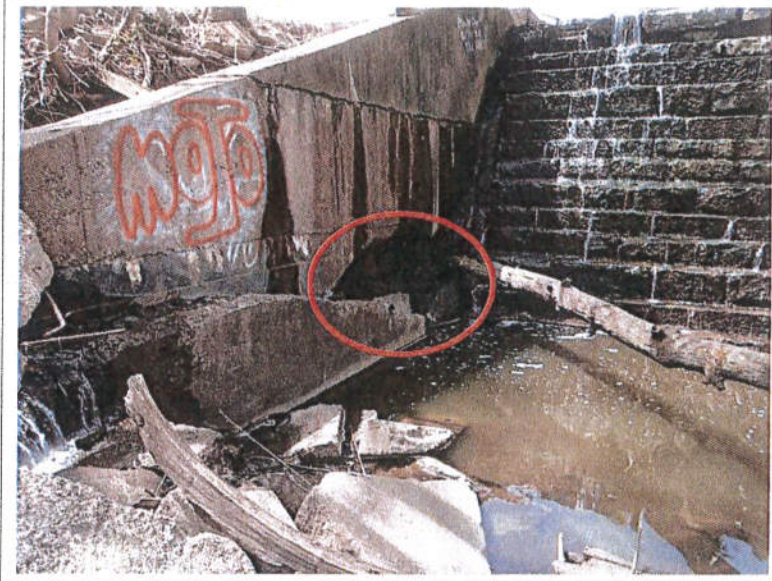
Photograph No. 10: Another view of the left sidewall. Note the severe damage to the concrete.
